# CASE STUDIES

### กรณีศึกษา 1: สเตเตอร์หลวม (Stator Looseness)

ระยอง : ประเทศไทย

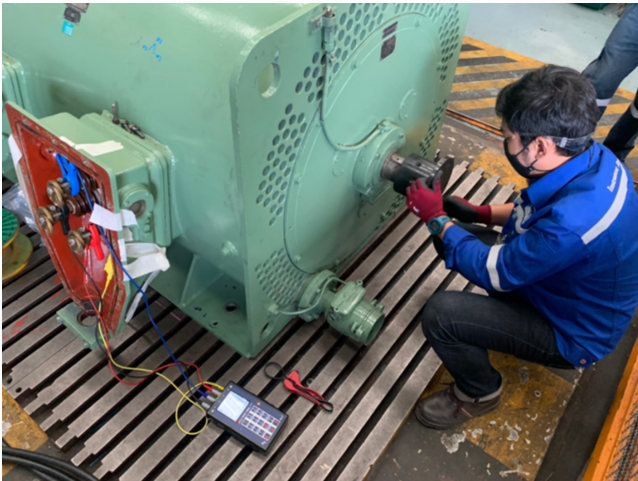
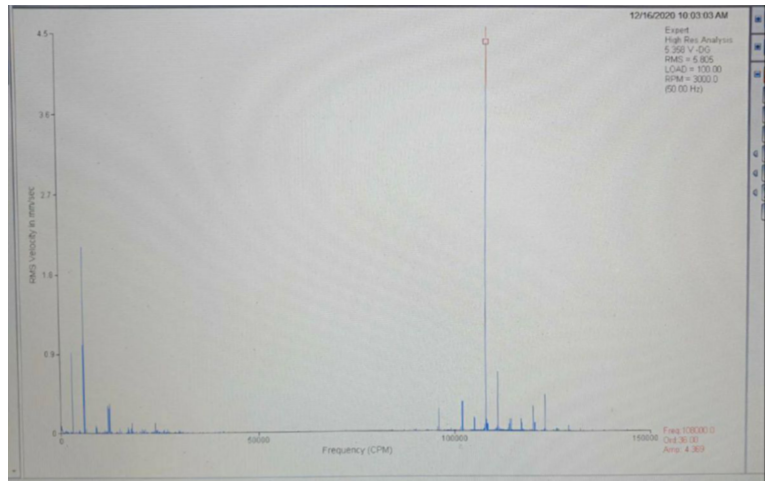
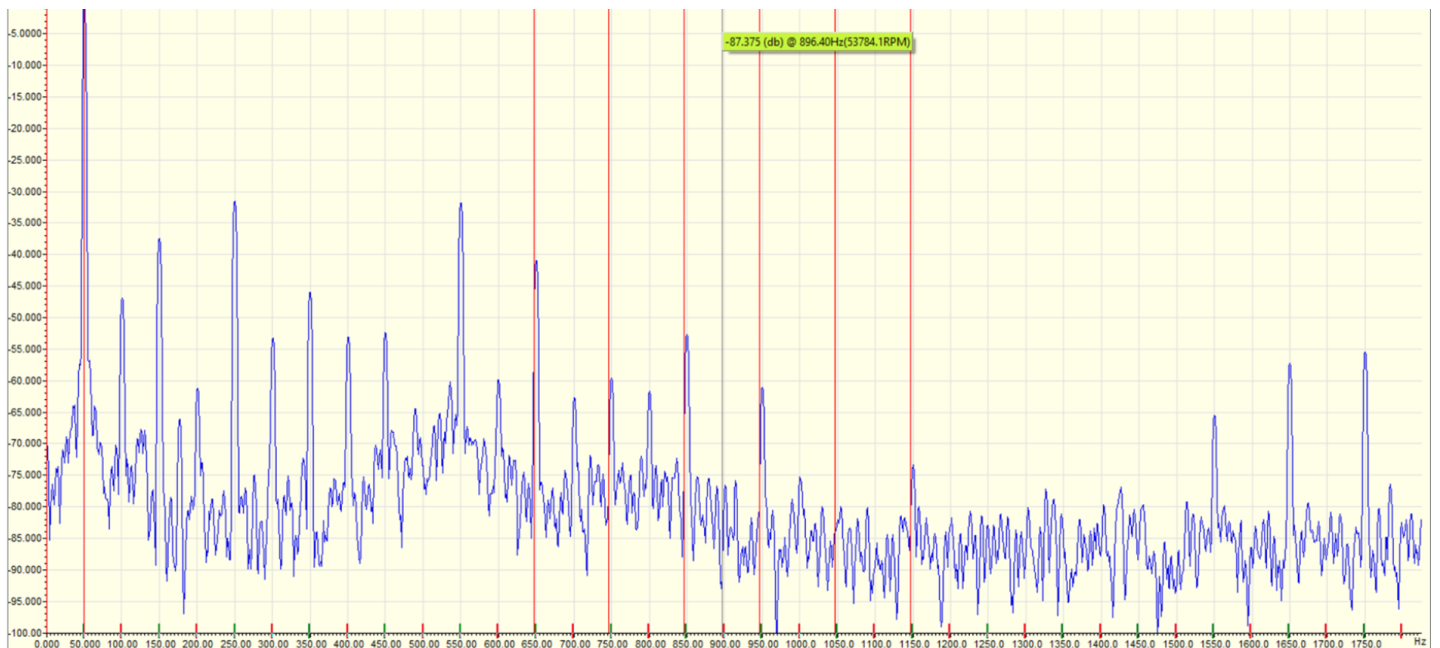
ทำการขอข้อมูลเพิ่มเติม ในส่วนค่า Vibration Spectrum จำนวน Rotor bar และ stator slot ไม่ตรงกับ fault frequency ที่ตรวจพบ

เนื่องจากผล Vibration Spectrum ทำให้ต้องตรวจ Magnetic Circuit เพิ่มเติม ตรวจพบความไม่สมดุลของสนามแม่เหล็ก แต่เช็คไม่พบความผิดปกติที่ขดลวด จึงแนะนำถอดเพื่อเช็ค Stator laminate พบมีจุดหลวมหลายจุด จึงแจ้งลูกค้าเพื่อดำเนินการแก้ไข
